November 30, 2010

**Subject: November 23, 2010 Site Inspection; 4th and Gambell Site; Anchorage, Alaska;
NTP 18-4002-11-007B**

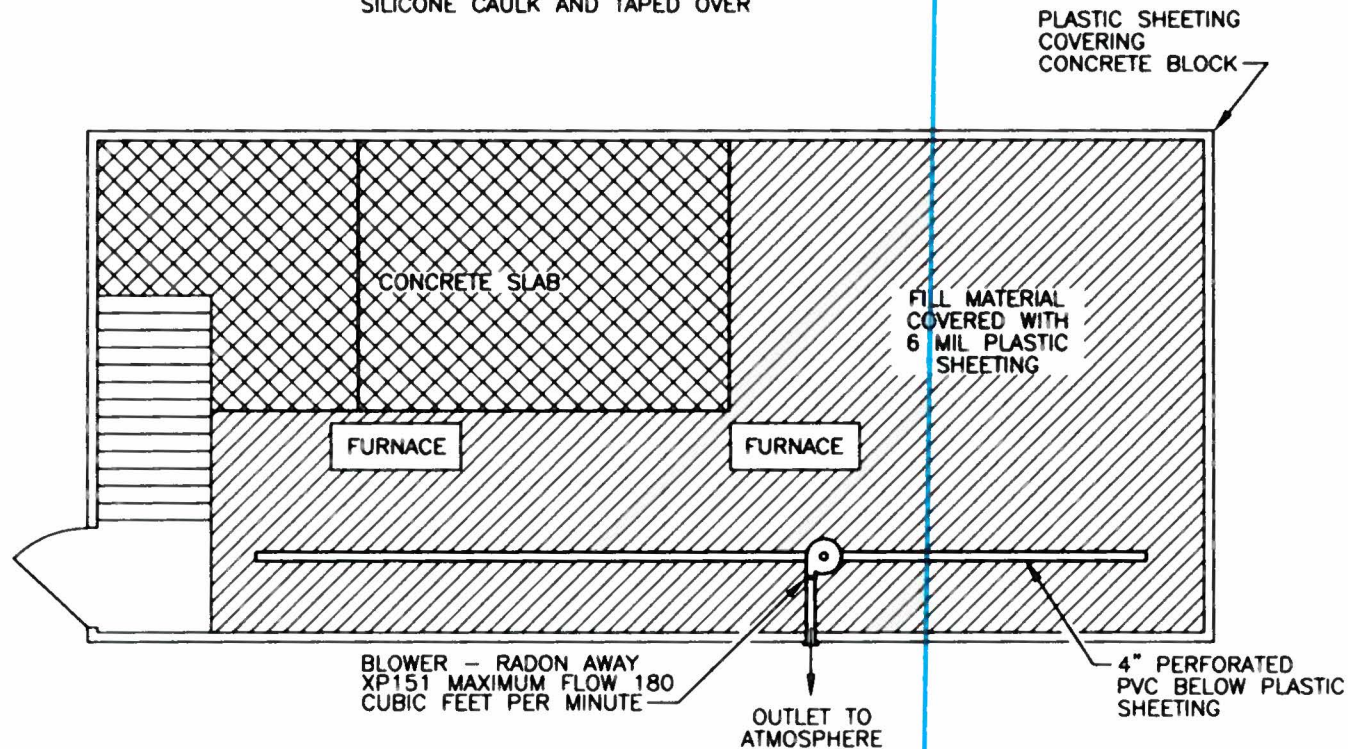
SUB-MEMBRANE DEPRESSURIZATION SYSTEM AT NORTH DUPLEX

NOTE:
ALL SEAMS BETWEEN PLASTIC
SHEETS ARE SEALED WITH
SILICONE CAULK AND TAPED OVER
